AEROSPACE REPORT NO.
TR-92(2935)-17

Long Duration Exposure Facility Experiment M0003 Deintegration/Findings and Impacts

M. J. MESHISHNEK, S. R. GYETVAY and C. H. JAGGERS
Mechanics and Materials Technology Center
Technology Operations

15 December 1992

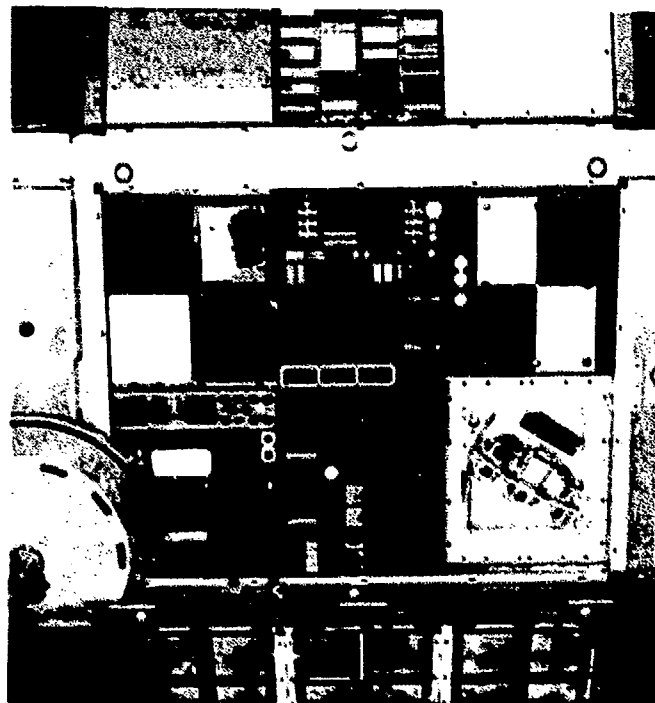
Figures 8 and 9 are representative on-orbit photographs of the M0003 trays. Several points are evident in these photos. Debris from atomic oxygen-eroded metallized Kapton radar camouflage specimens is scattered about the D9 tray. Polymer film strips, such as Kapton and silver Teflon (Ag/FEP) are broken and are projecting above the surface on both the D9 and D3 trays. Solar cells are missing on both the D3 and D9 trays due to an adhesive failure. Typical atomic oxygen (AO) erosion phenomena are apparent on the D9 tray, while UV degradation is more prevalent on the D3 tray. There is evidence of contamination due to outgassing on both trays. The painted sunshield on D4 has darkened due to UV damage, while its counterpart on D8 has remained white.

Figure 8. On-orbit photograph of D9 tray, leading edge. Note the debris above the surface from AO-deteriorated materials on the tray

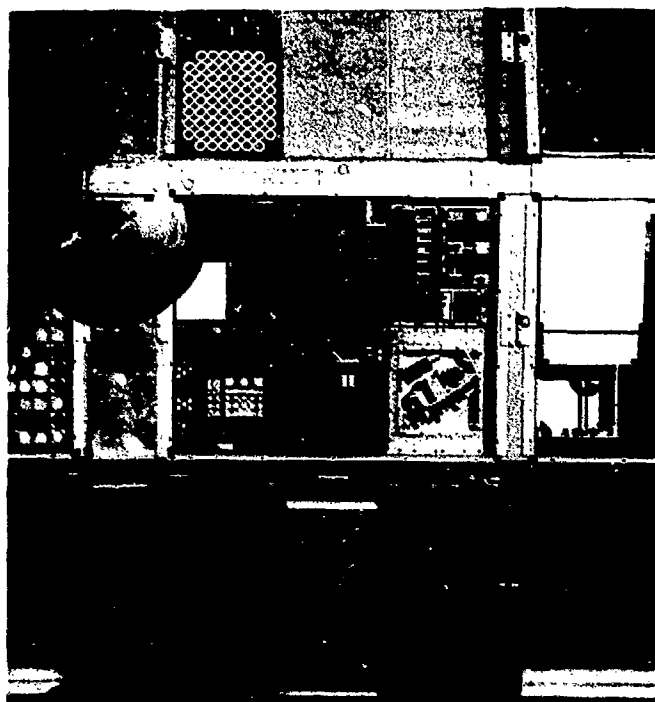
Figure 9. On-orbit photograph of D3 and D4 trailing edge trays. Most noticeable effects are contamination-staining and darkening of white paint coatings

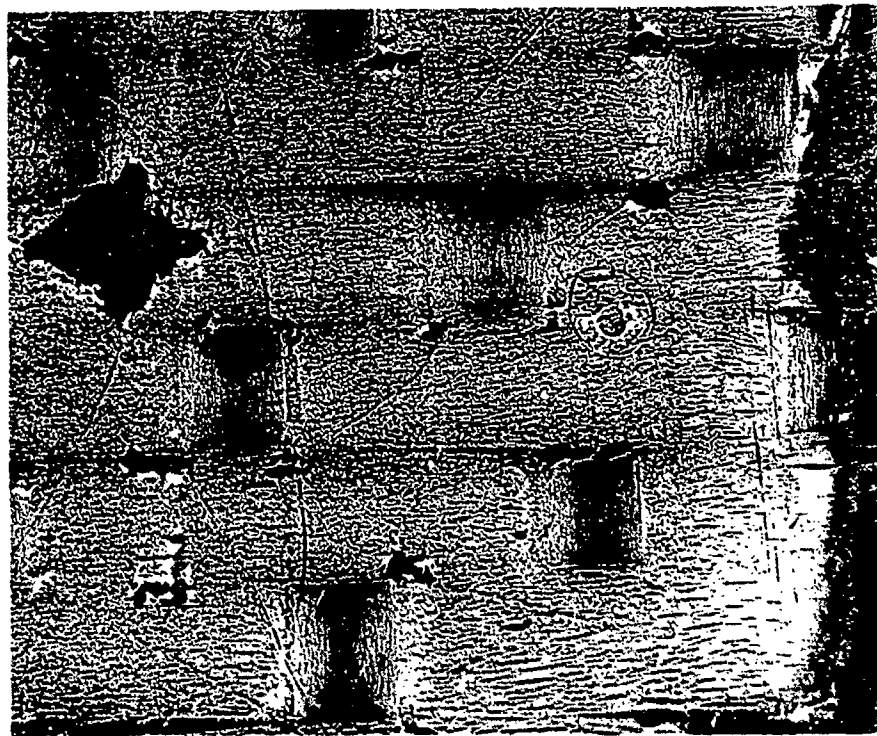
Many craters from micrometeoroid and space debris impacts were observed on these composites. The damage was confined to the immediate area of the crater on both leading and trailing edge specimens, but subsequent atomic oxygen erosion enlarged the affected area a slight amount on leading edge specimens. Typical AO damage to a composite is shown in Figure 23.

Figure 23. Atomic oxygen-eroded surface of graphite-epoxy composite test article exposed on D9 (LE). Note enlargement of impact crater, upper left. Masked, unexposed surface is at right edge of photo

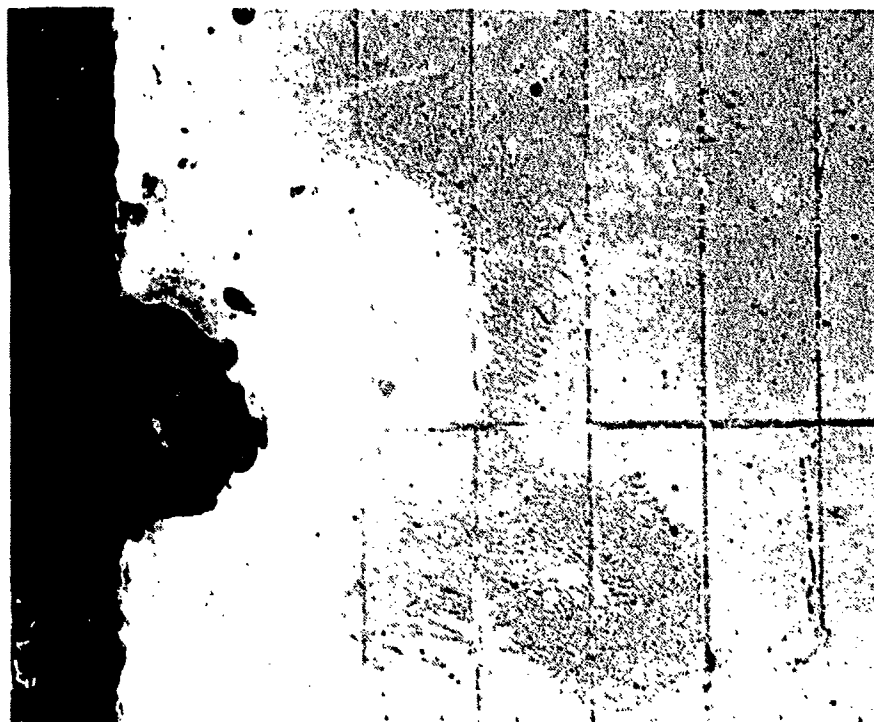
Examination of the cell strings after retrieval showed the cover glasses over the cells were superficially contaminated. The silver welds on the interconnects appeared intact, but localized delamination of the cover glass was apparent on some cells around the welds. Since the current measurements did not show any significant change in the performance of these cells, this degradation probably occurred after the data recording period. The damage is illustrated in Figure 24.

Figure 24. Localized delamination of cover glass near silver weld on LE solar cell

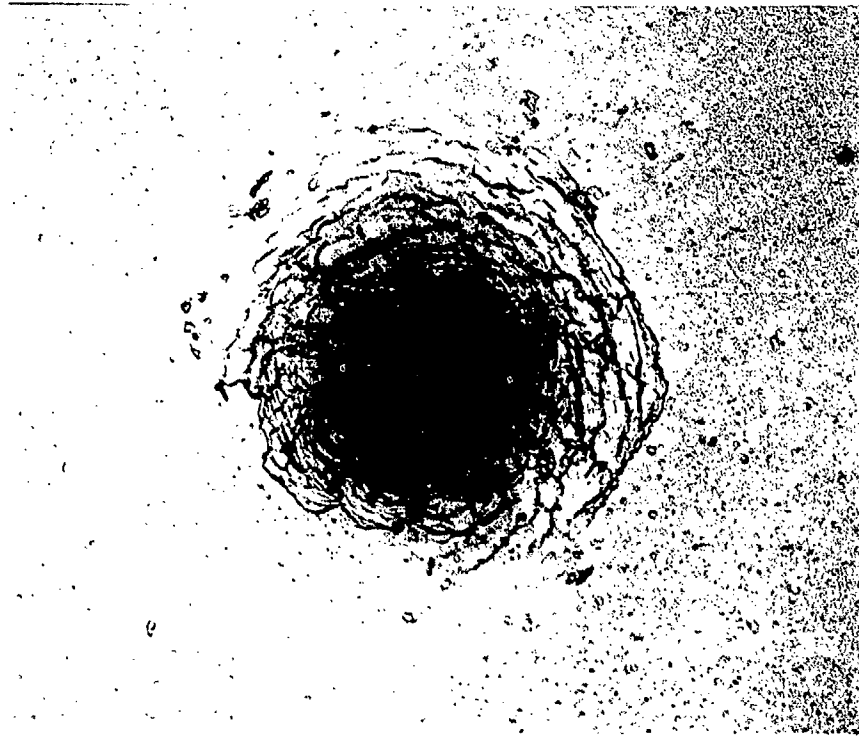
Hypervelocity impacts on the cover glasses of the solar cell strings and the individual specimens produced craters surrounded by localized damage in the glass. The presence of the craters of the size found on the M0003 test articles would likely impair solar cell performance only by the obscuration of the cell across the very small area of the crater. Typical damage in a solar cell is depicted in Figure 25.

Figure 25. Typical micrometeoroid/debris damage in a solar cell cover glass

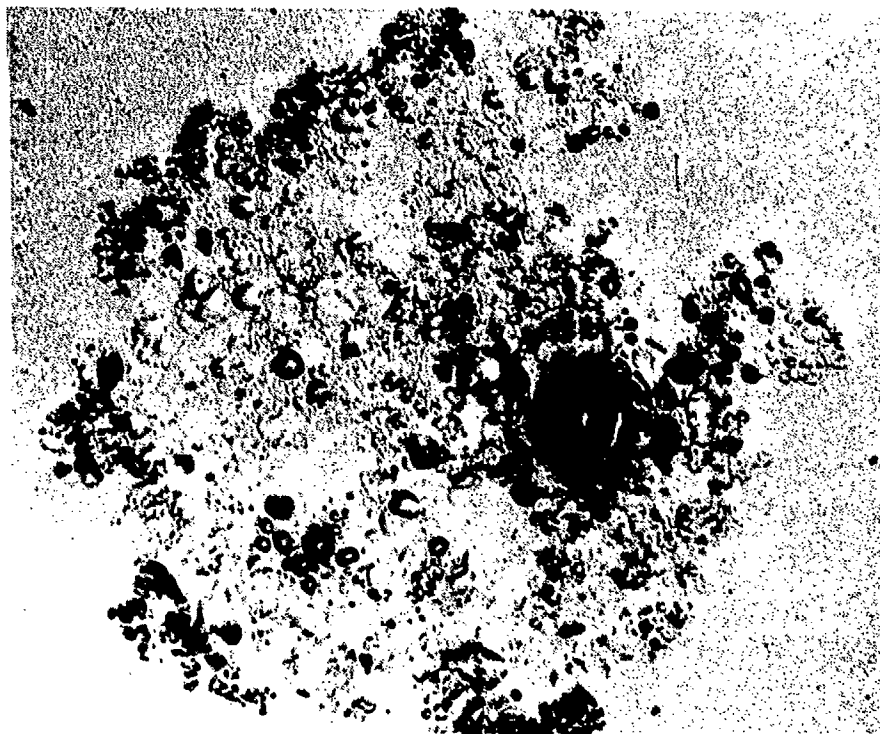
Hypervelocity impacts created craters surrounded by localized damage on many optical specimens. The greatest expanse of damage occurring due to impact was a 1-cm circle of blistered coating surrounding a ~1-mm diameter crater on a mirror specimen, shown in Figure 26. Coated sensors or windows that are exposed to solar UV, atomic oxygen, or micrometeoroids can experience significant optical performance degradation if the coatings are disrupted.

Figure 26. Blistered coating damage surrounding ~1-mm dia. impact crater in LE ThF₄/Ag/Mo mirror test article

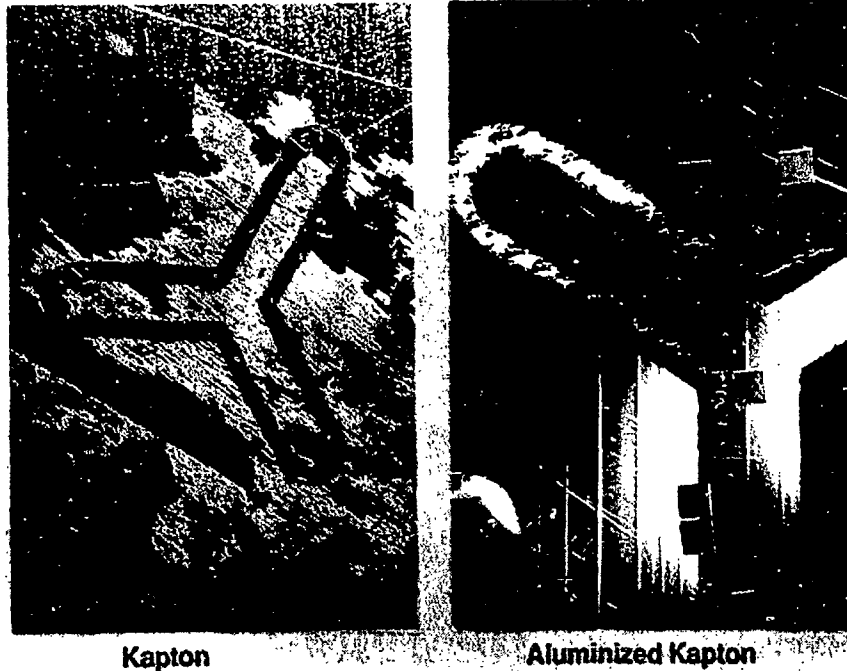
Figure 27. Atomic oxygen erosion of aluminized Kapton radar camouflage material. This produced significant debris which became scattered over many LDEF trays

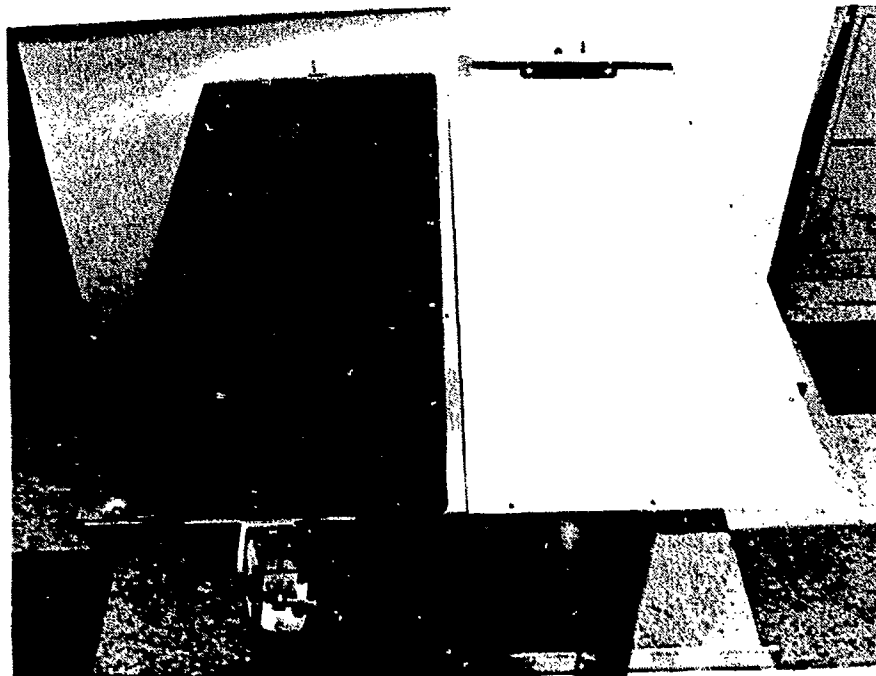
Figure 28. Chemglaze A276-painted sunshields flown on D4 (TE) on left and D8 (LE) on right

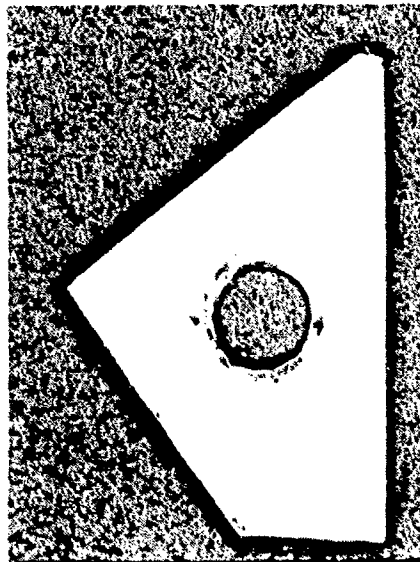
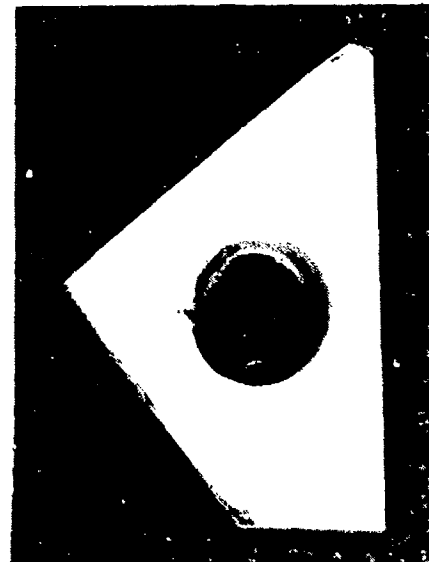
Figure 30. Response of masked Chemglaze A276 to UV radiation

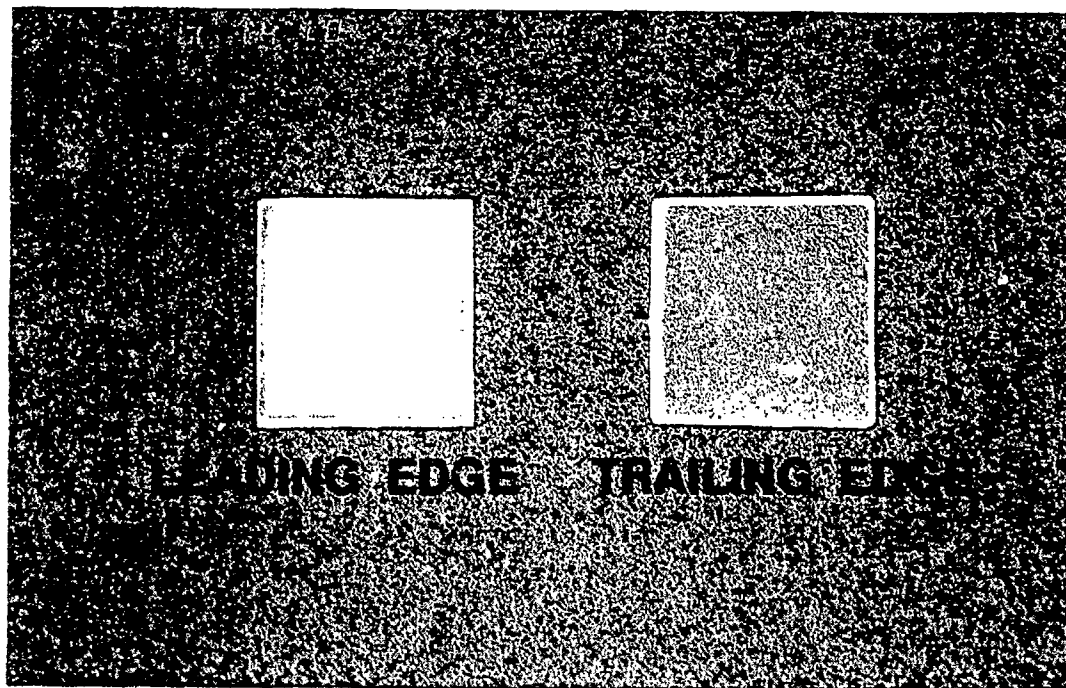
Figure 31. Side-by-side comparison of LE/TE S13GLO test articles

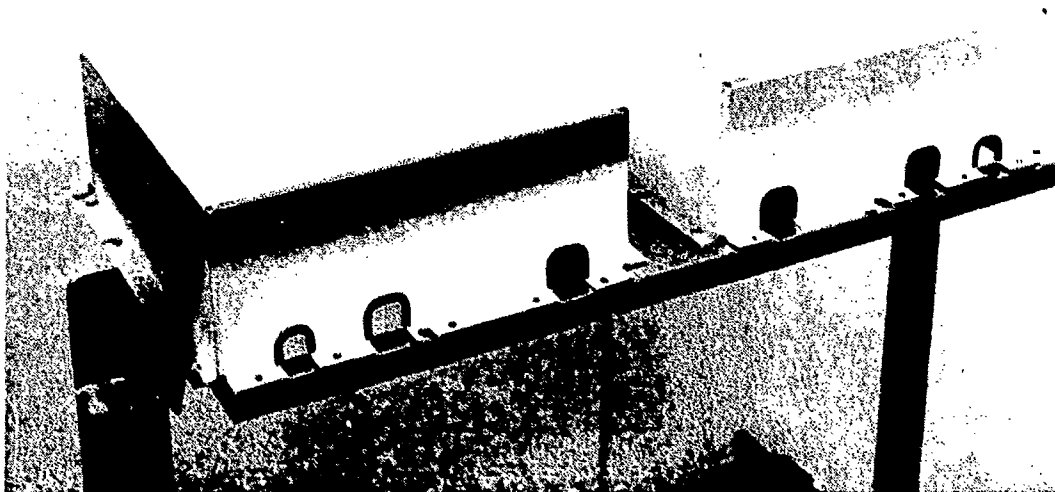
Figure 32. Signal conditioning unit (SCU) covers showing dramatic differences in damage from LE to TE. Note marked outgassing patterns on LE cover

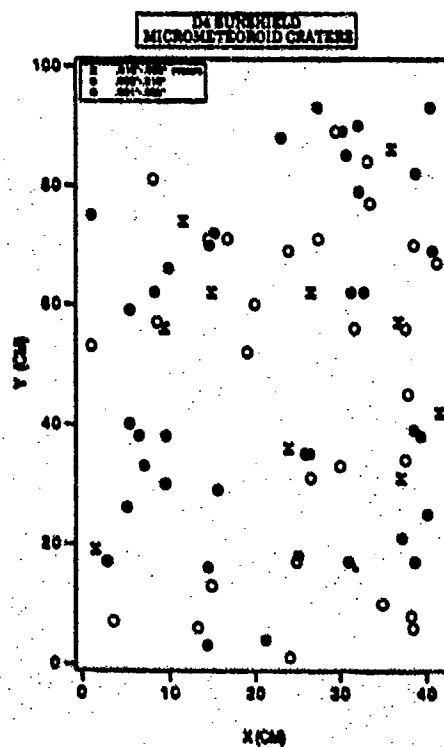
Figure 34. Micrometeoroid/debris impacts on TE EPDS sunshield

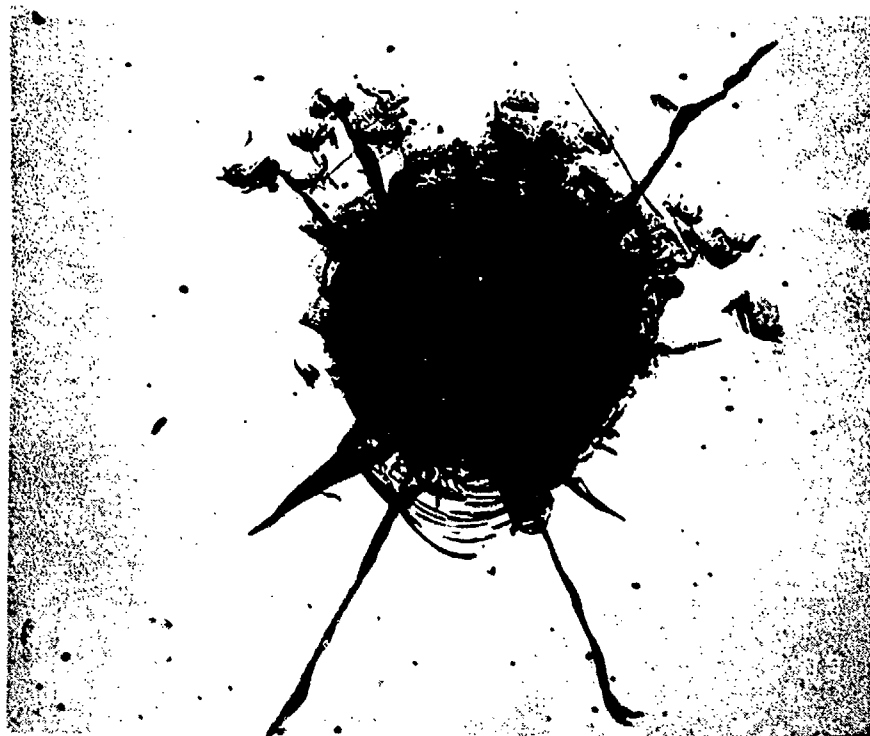
Figure 37. Impact crater (1.25 mm dia.) in glass test article

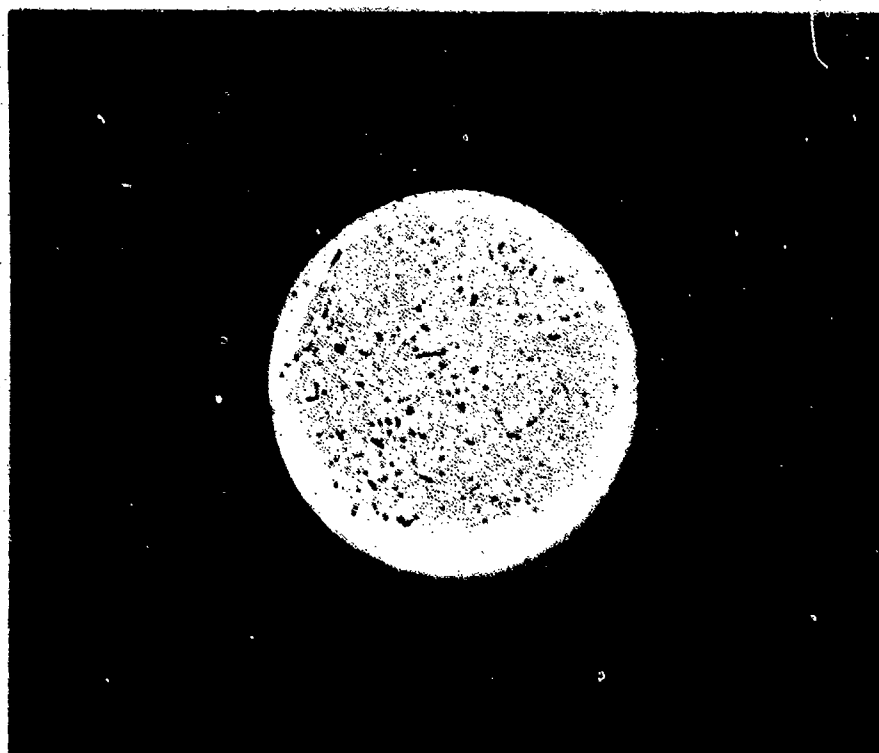
Particulate contamination on individual test articles could be identified as originating from deteriorated nearby materials on M0003 and other LDEF trays. Debris found on test articles flown in the canisters, particularly fibrous debris (Figure 40), may have come from the shuttle payload bay covers.

Figure 40. Debris contamination adhered to surface of 1.5 in. dia. silicone-based white paint test article exposed for 40 weeks in the TE (D8) canister
